Manhole Inspection Summary

Manhole # S29I__010MH

Insp Date: **9/11/08 11:21 AM**

Location Address: **767 Otterbein**

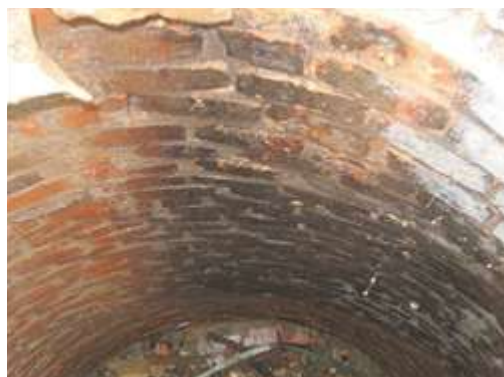
Defect 4

Infiltration: ☐ None ☐ Joint ☐ Cracks ☒ **Mortar** ☐ Roots ☐ Wall

infiltration @ chimney/frame joint

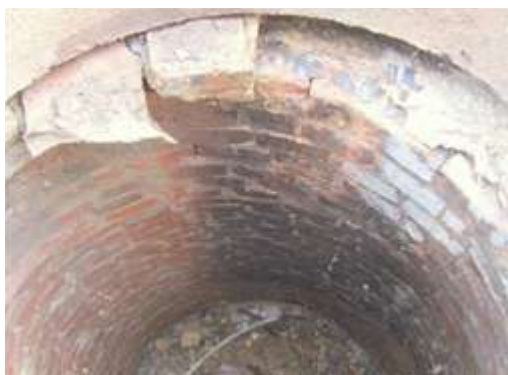
Defect 1

Offset: **2** (in.)

offset 2 inches

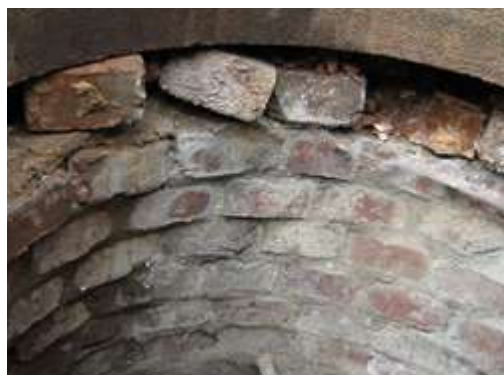
Defect 3

Condition: ☐ Sound ☐ Cracked ☒ **Root Intrusion** ☒ **Loose Brick** ☒ **Deteriorated**

loose bricks and missing mortar

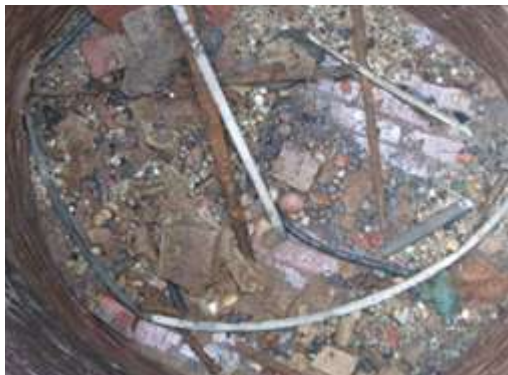
Defect 2

Condition: ☐ Sound ☐ Cracked ☐ Root Intrusion ☐ Deteriorated ☐ Leaks ☒ **Debris**

Channel Debris

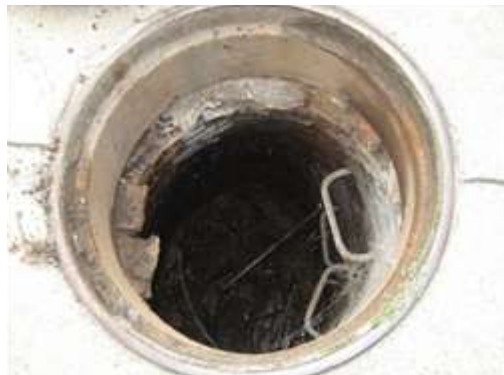
defect 5

Condition: ☐ Sound ☐ Cracked ☒ **Leaks**

frame leaks

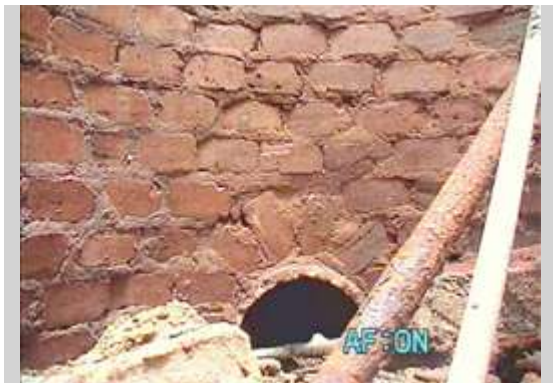
12 O'Clock Outflow

6 in. Circular Gravity Sewer
Pipe Out @ 12 O'Clock

Infiltration: **None** Pipe Seal Cond: **Sound**
